**Sixth Five-Year Review Report
for
Celanese Corporation (Shelby Fibers Operations)
NCD003446721**

**Grover
Cleveland County, North Carolina**

August 2016

**United States Environmental Protection Agency
Region 4
Atlanta, Georgia**

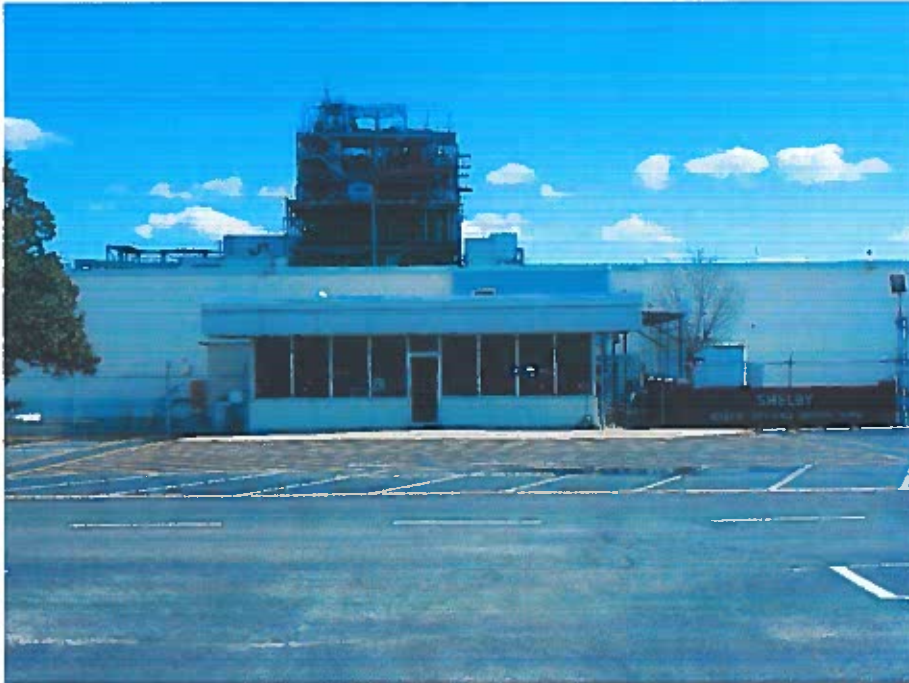
Main site entrance

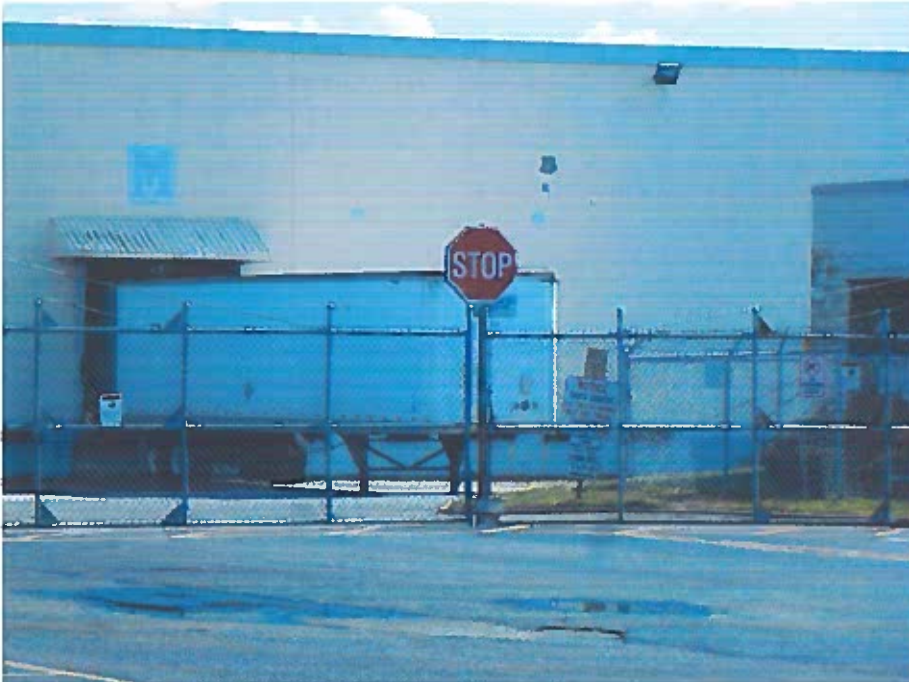
Security gates restrict vehicular access to the Site

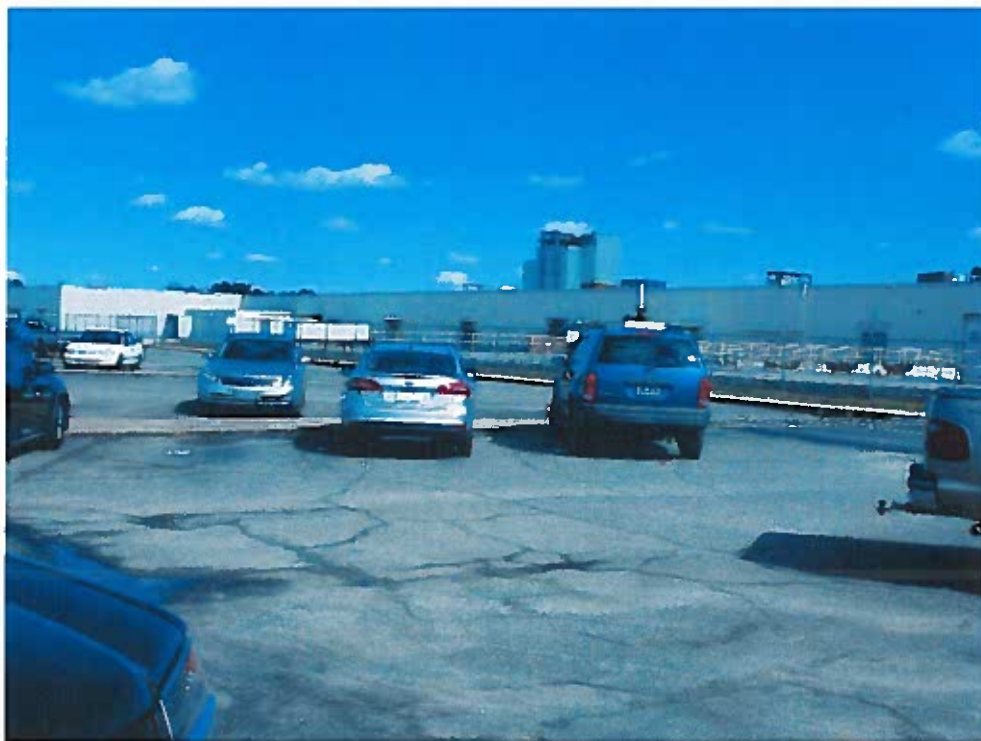
View of the Celanese facility from the parking lot

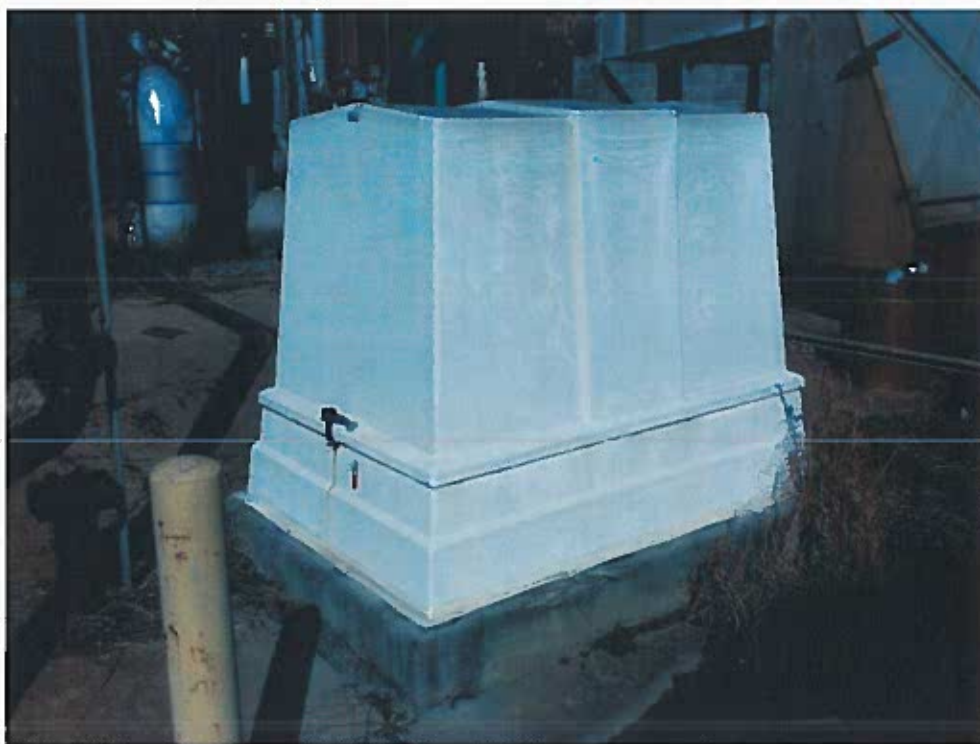
Extraction well PEW-3, located east of the main facility building

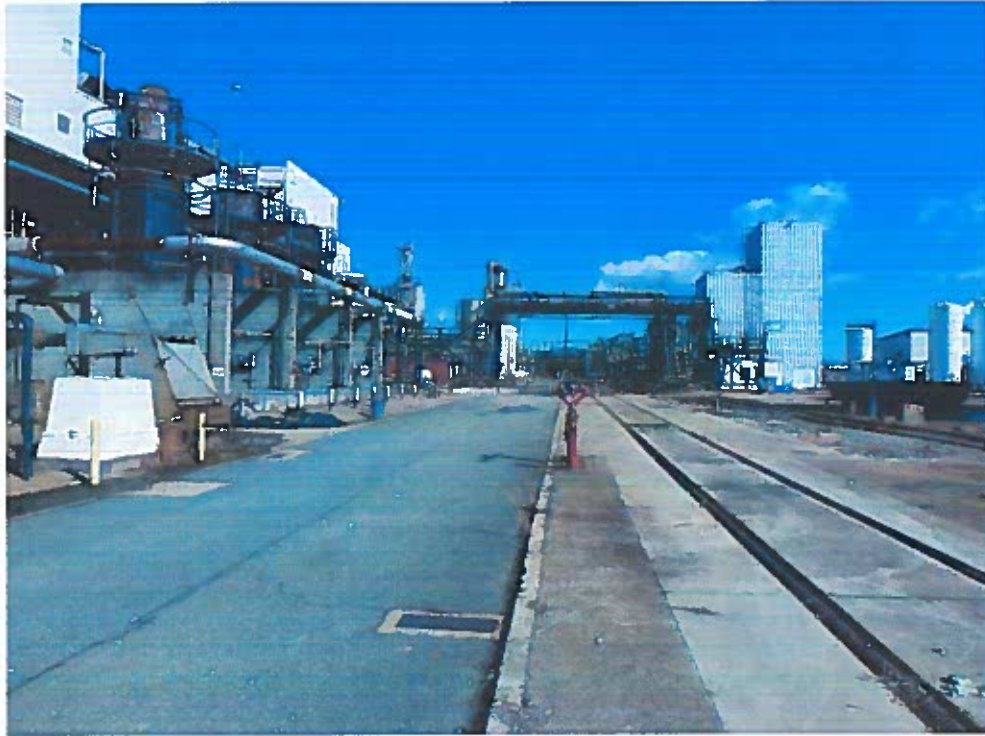
View of the back of the Celanese facility, looking north – extraction well PEW-3 is pictured to the left

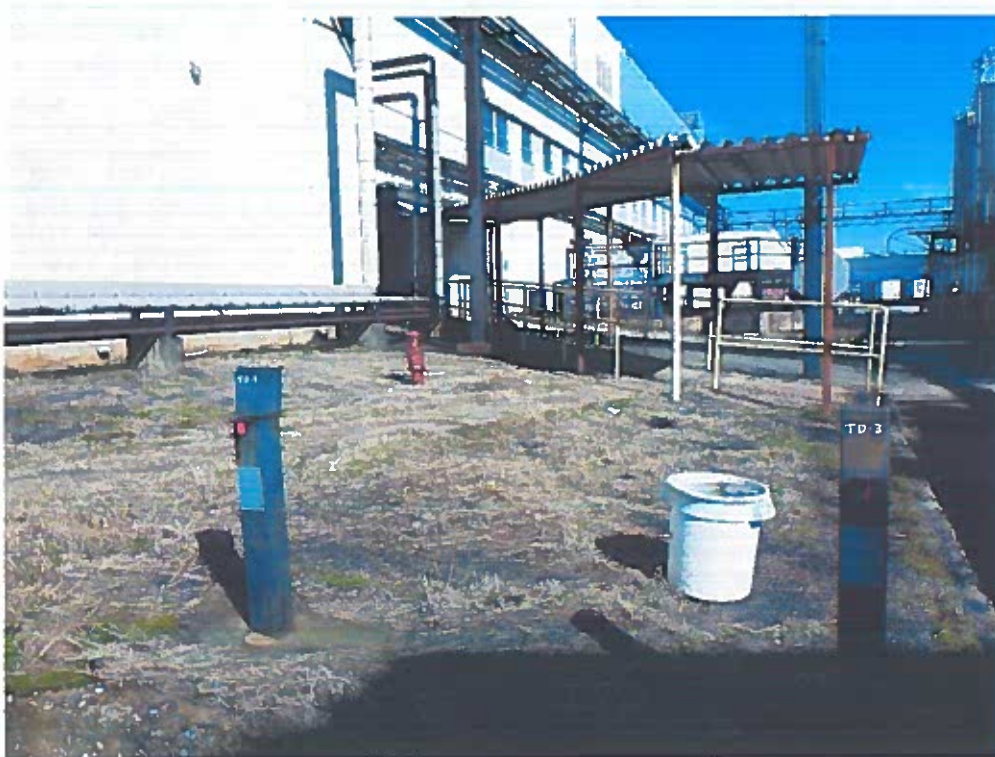
Between March and May 2012, AECOM investigated the TD well area to delineate the vertical and lateral extent of TCE in groundwater and to investigate possible sources. The investigation found that TCE concentrations in groundwater in the vicinity of TD-3 and TD-4 increase with depth. The

investigation found a lack of TCE daughter/breakdown products in the groundwater samples, indicating that TCE in the area of TD-3 and TD-4 is not degrading. TCE concentrations at wells south and southeast of the TD well cluster are consistently below the North Carolina 2L groundwater standard (wells TD-2 and I-57), indicating that the TCE plume is not migrating in that direction. TCE concentrations at well PEW-1, located northeast of the TD well area, remain elevated above state and federal standards and show a slight increase over time. These data indicate the possibility of TCE plume migration from the TD well area, toward the northeast (Figure 4).

Concentrations of site-related COCs in groundwater routinely exceed North Carolina groundwater standards. TCE concentrations at wells TD-3, TD-4 and QQ-110 consistently and significantly exceed the North Carolina 2L groundwater standard of 0.003 mg/L and the MCL of 0.005 mg/L. In general, since March 2011, TCE concentrations tend to fluctuate sitewide, with no significant trends observed. Groundwater monitoring results do not indicate that MNA is effectively addressing TCE concentrations at the TD well area. Between June 2006 and March 2015, the DNAPL thicknesses measured in well F-55 showed an overall increase. This increase suggests that MNA and the operation of the GWRS may not be capable of addressing the source of DNAPL at well F-55. Monitoring data indicate that concentrations of 1,4-dioxane above the 0.003 mg/L cleanup goal are common at most site monitoring wells. Detectable concentrations of 1,4-dioxane in surface water indicates that the constituent is being discharged from groundwater into site streams. However, between March 2011 and March 2015, concentrations of 1,4-dioxane in site surface water did not exceed the NCAC 2B surface water standard of 0.08 mg/L. With the possible exception of 1,4-dioxane, groundwater monitoring data suggest that groundwater COCs are not migrating off site. It is expected that the continued operation of the GRUB area GWRS will help address the source of 1,4-dioxane. However, given the prevalence of elevated 1,4-dioxane concentrations sitewide, additional actions may be needed to adequately address the contaminant in site groundwater.

Monitoring wells TD-3 and TD-4, located immediately east of the DuraFiber facility

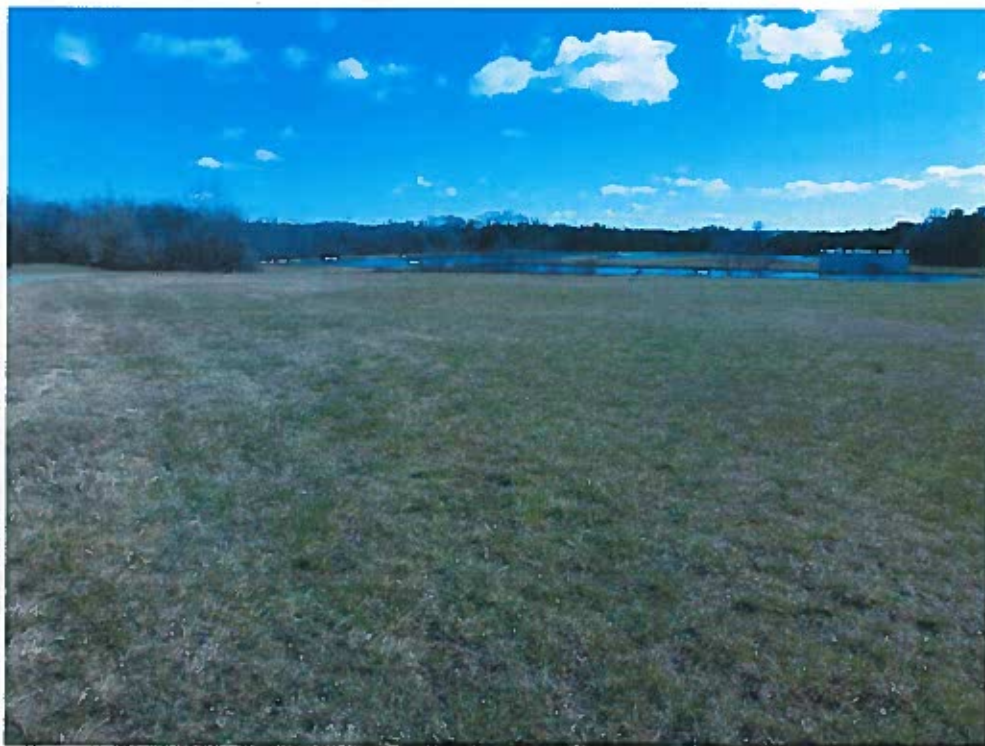
Site inspection participants observed the former GRUB area. Vegetation at the former GRUB area is well established and appeared healthy. Participants then observed the three recently installed extraction wells (IT-10, IT-11 and IT-12) and the facility's WWTP. The WWTP was operational at the time of the site inspection. All WWTP system components appeared to be functioning as designed.

View of the former GRUB area, looking northeast

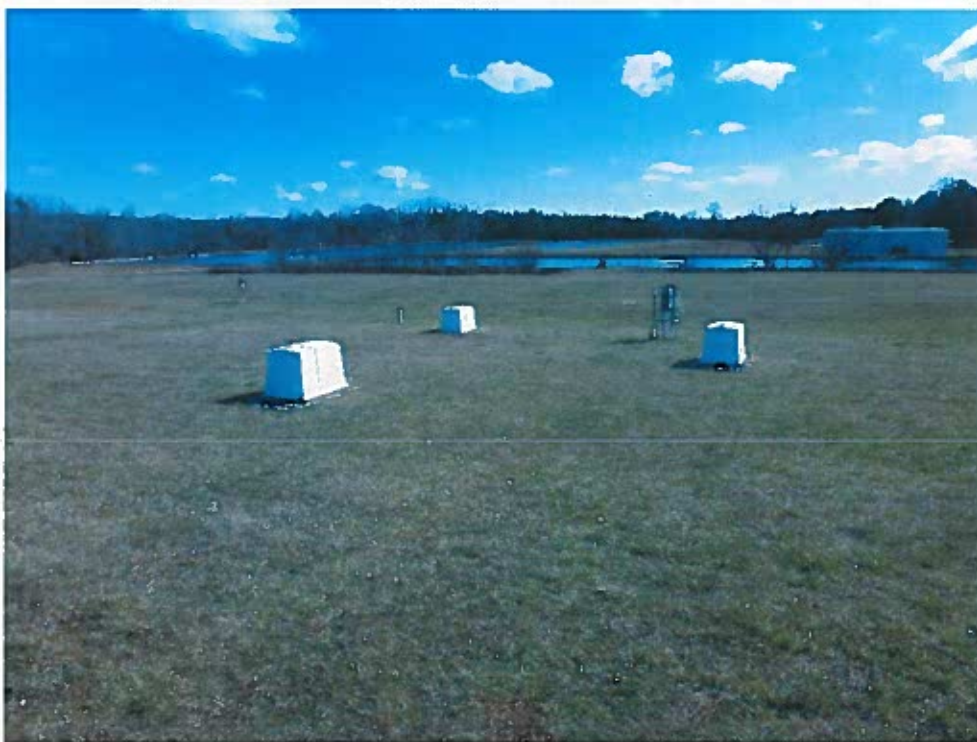
Extraction wells IT-10, IT-11 and IT-12 – WWTP ponds are pictured in the background

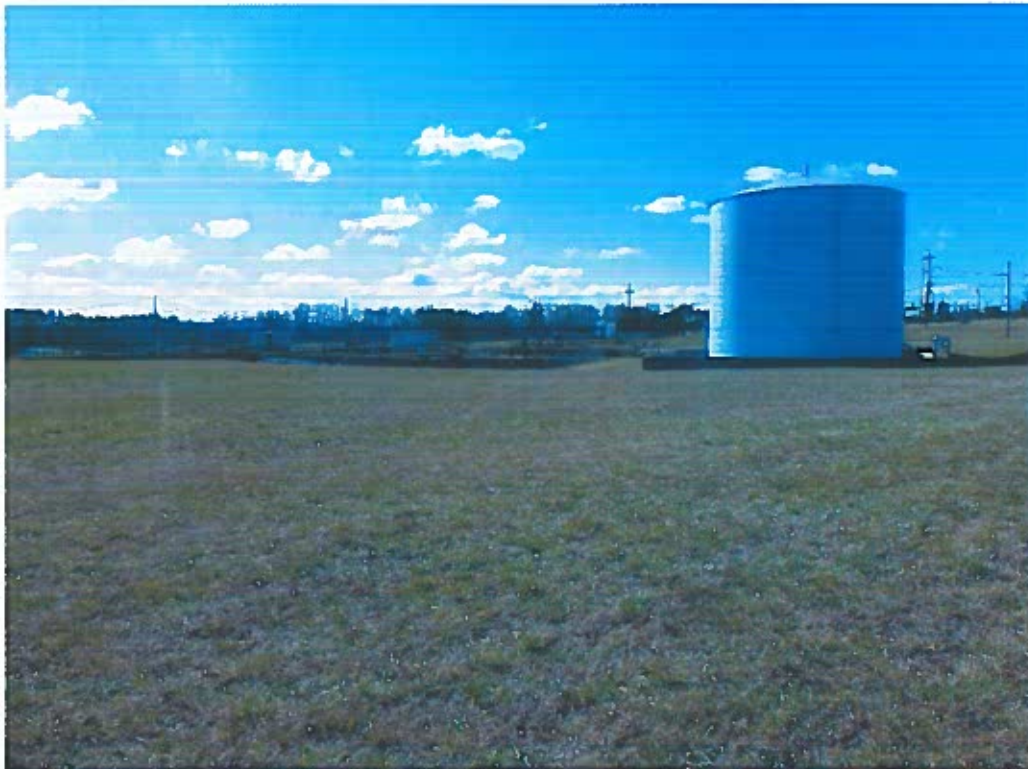
View of the WWTP, looking south from the former GRUB area

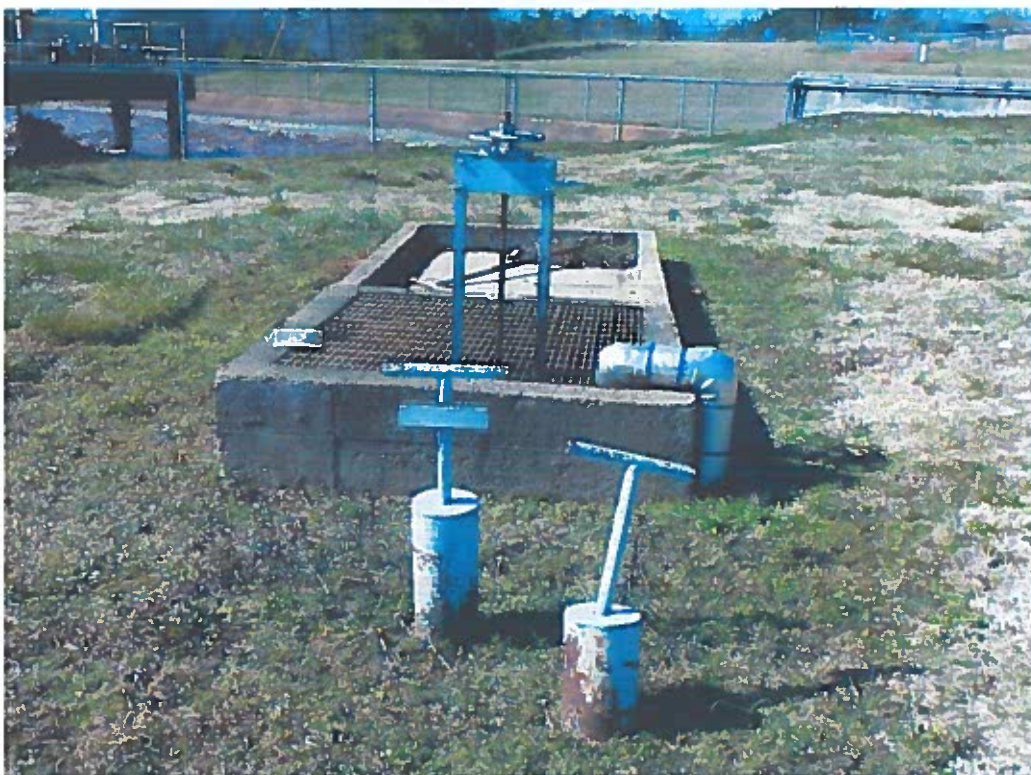
WWTP headworks

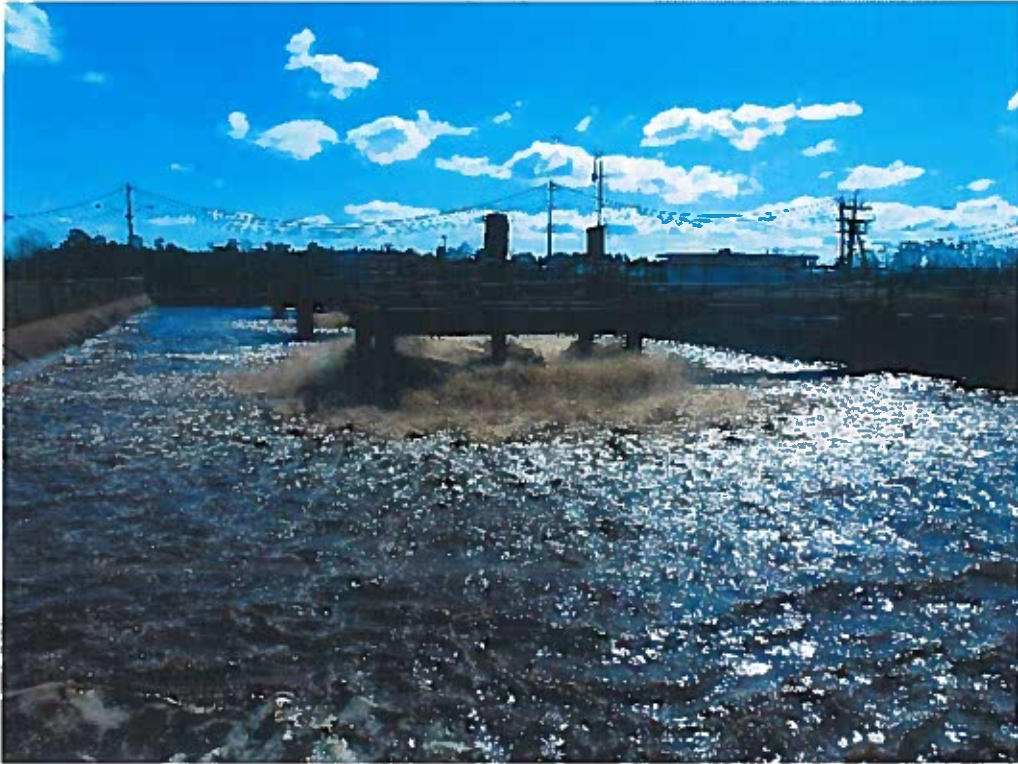
WWTP aeration basin, looking south

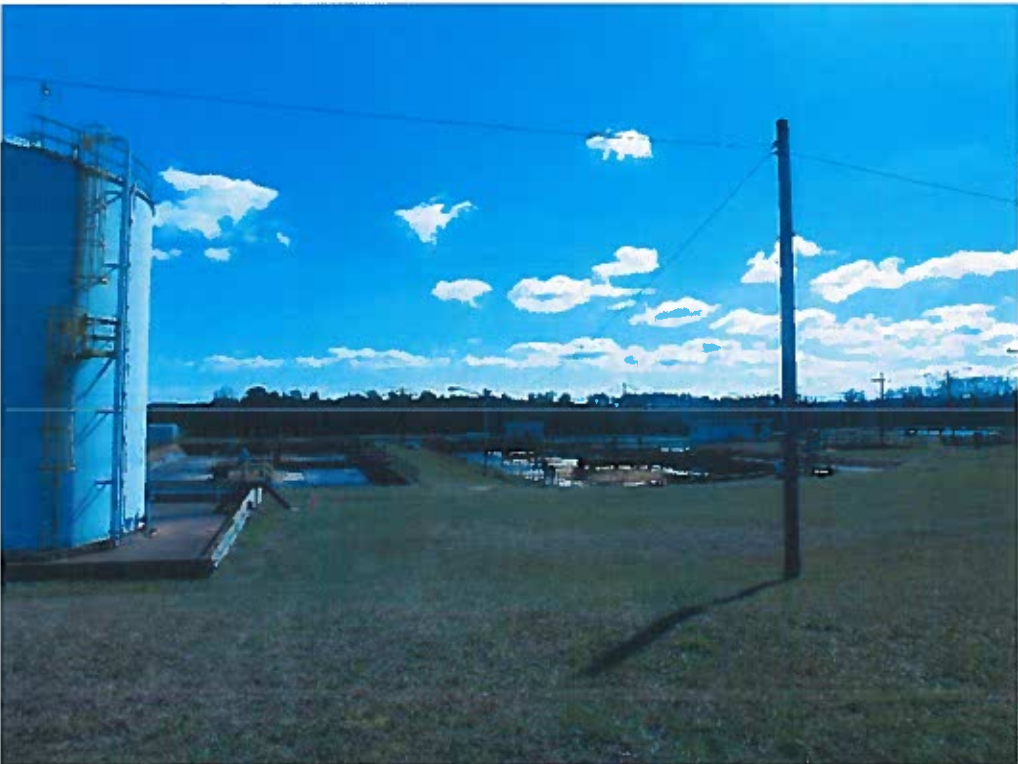
View of the WWTP, looking east

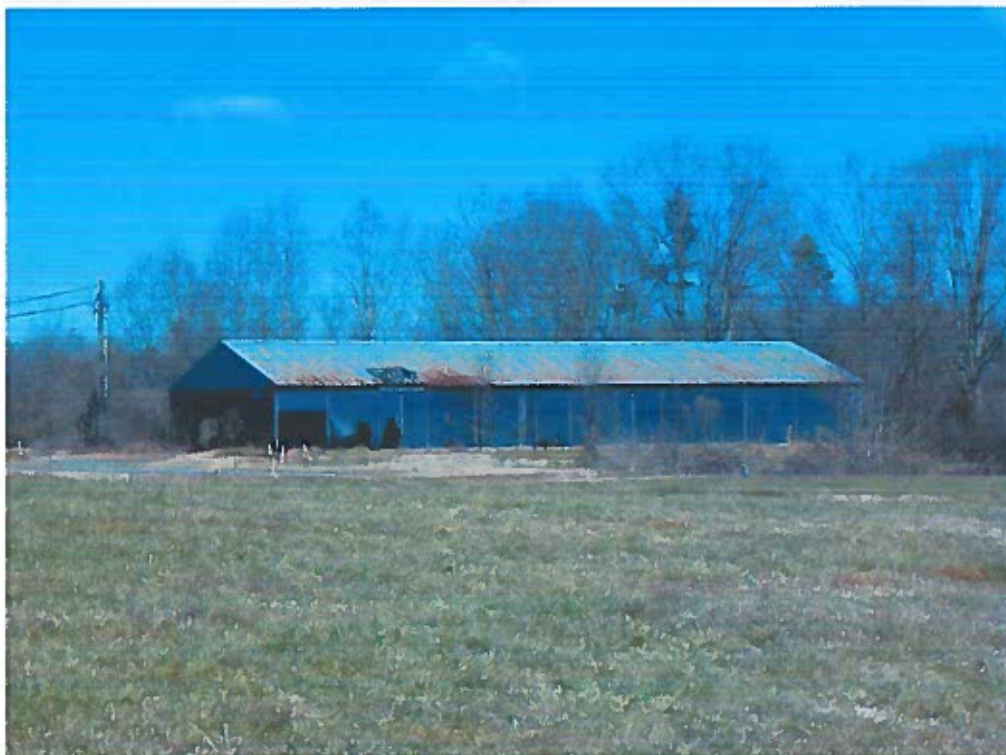
The inspection team observed the former location of the incinerator and the remains of the building previously used to stage and store materials during the operation of the incinerator. North of the former incinerator location, the site inspection team observed the section of Stream B where remediation took place, near surface water sampling point SW-5. The stormwater discharge point near SW-5 appeared to be in good condition and fully operational.

Remnants of the warehouse previously used to stage and store materials during incineration activities

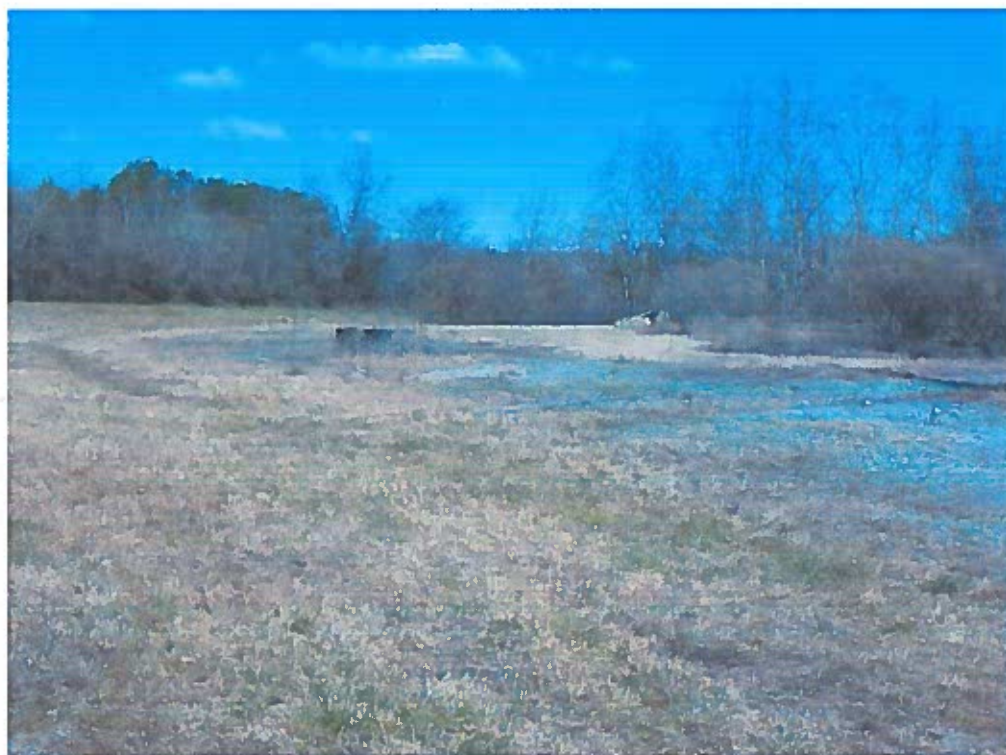
Former location of the on-site incinerator

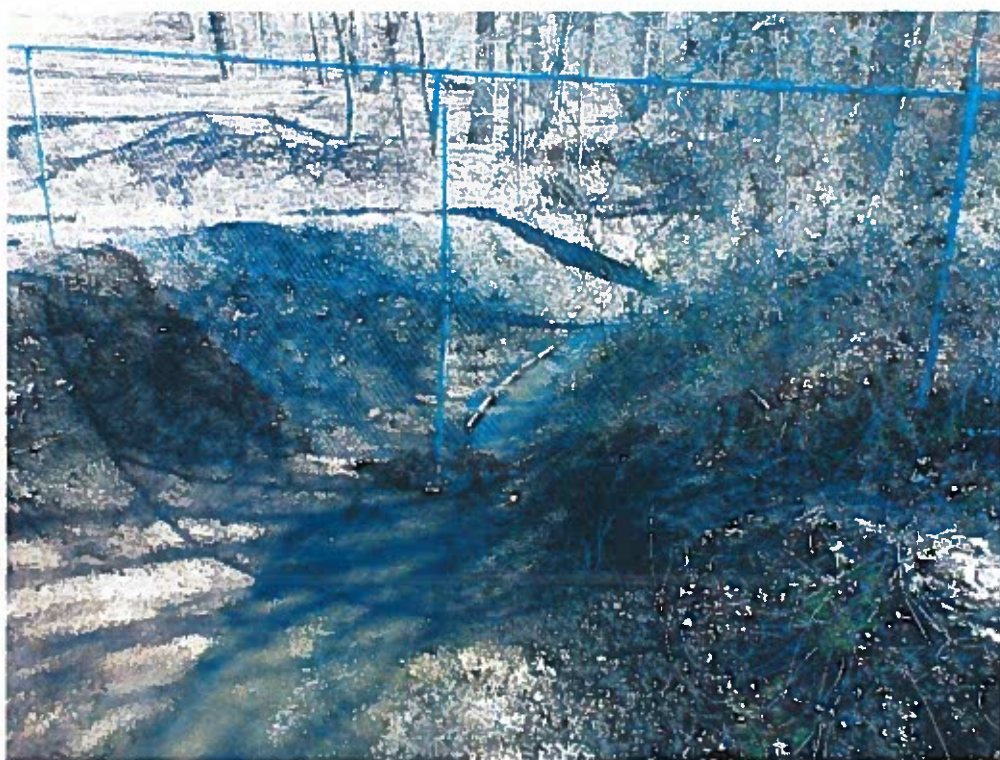
Looking east toward Stream B where remedial actions took place, and toward surface water sampling location SW-5

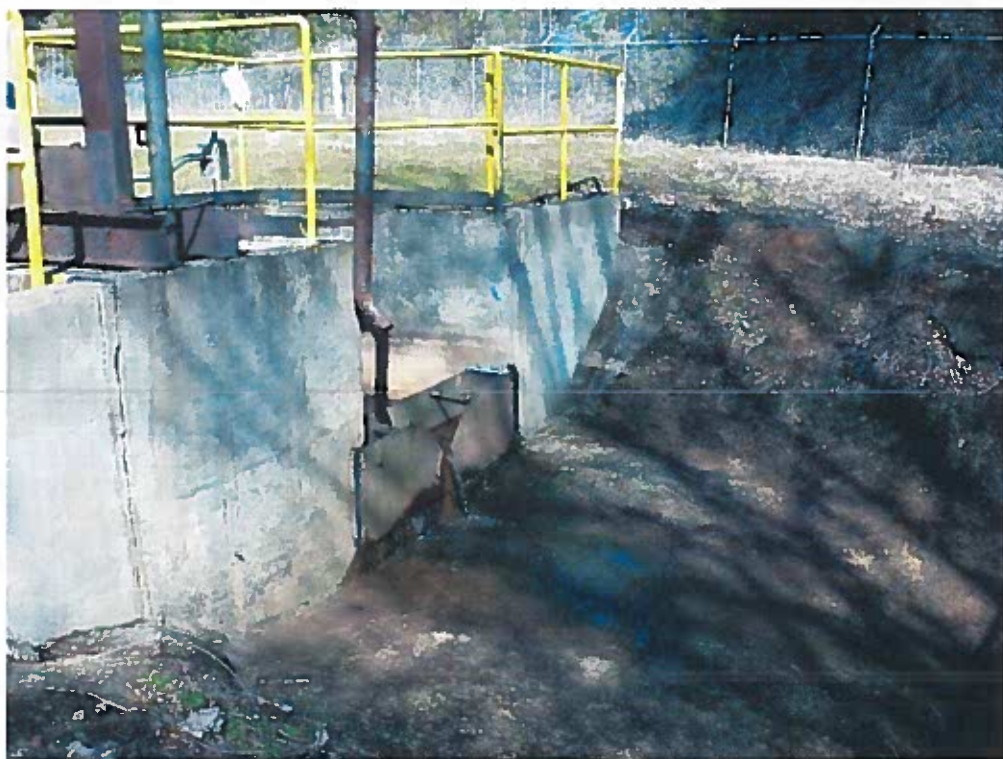
Stormwater discharge structure, located immediately upstream from Stream B
